Bridge Adaptation

Bridge Adaptation on a Global Perspective

Old I-10 Twin Span Bridge

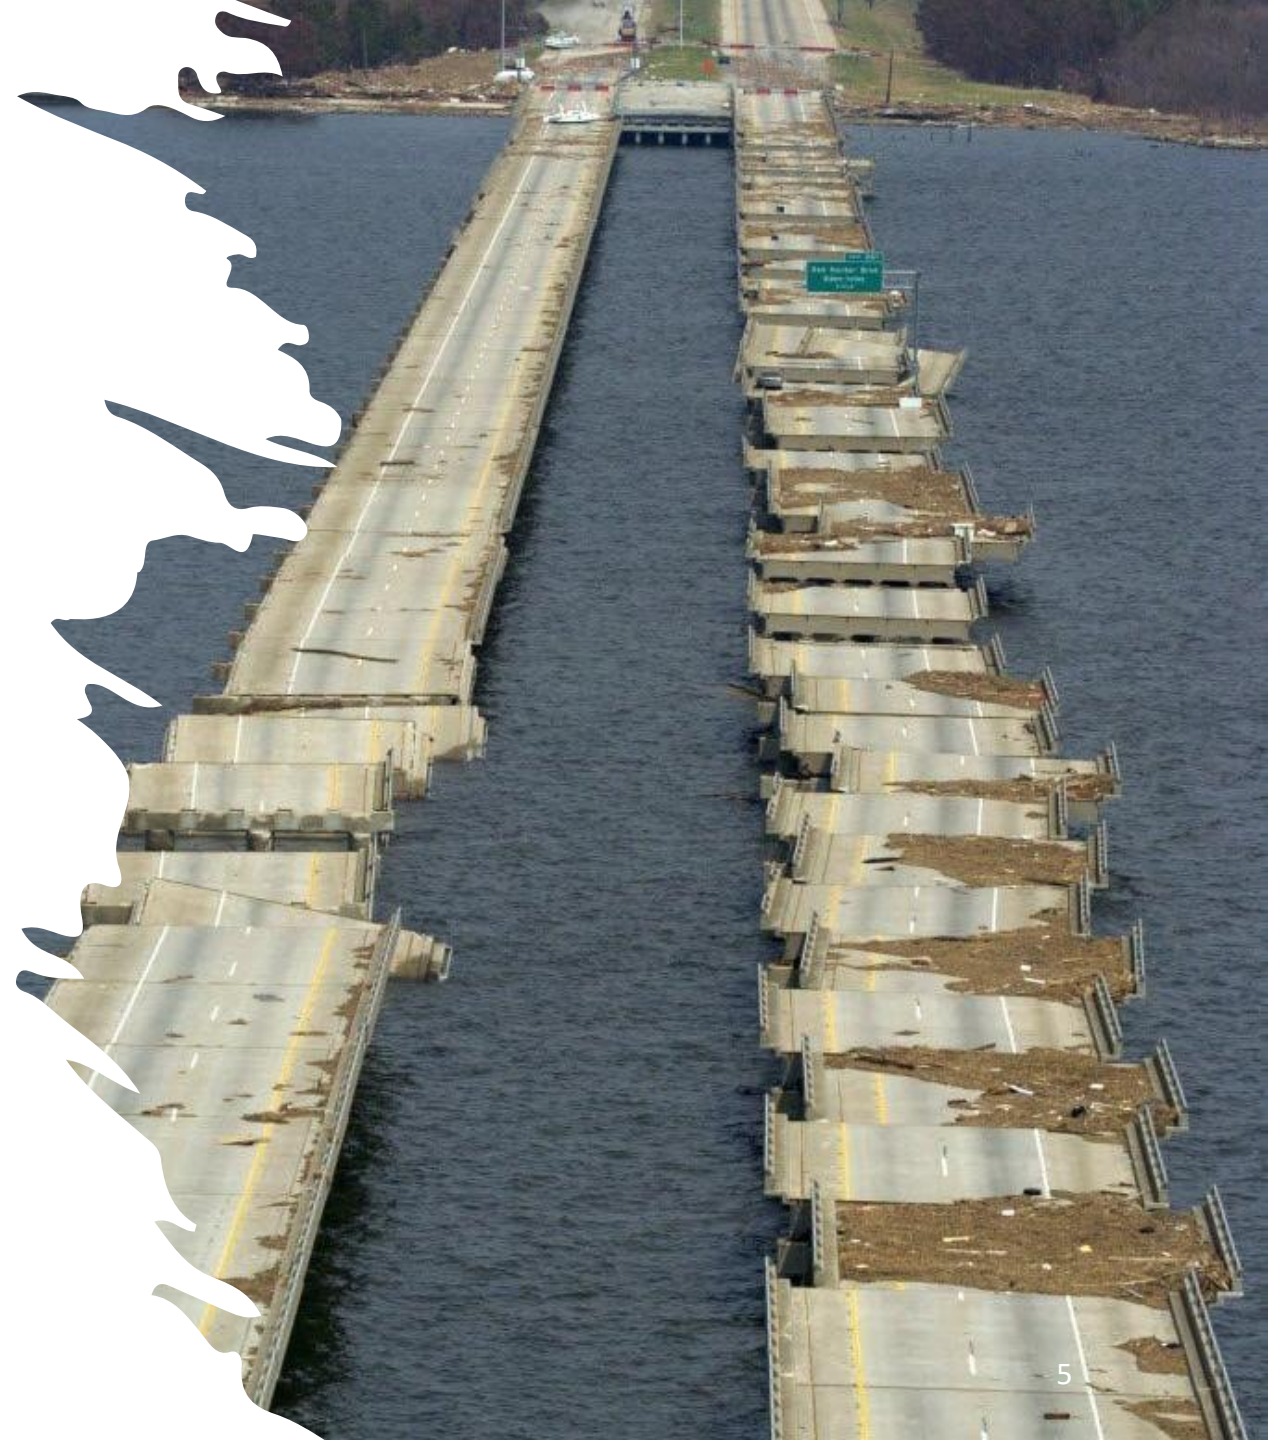
Damage Observed

- 58 spans failed:
 - 38 eastbound spans
 - 20 westbound spans
- Lateral displacement of 1–2 girder spacings before falling off supports.
- Approach spans experienced nearly all failures — low elevation + hollow girders made them highly vulnerable.
- Substructure mostly intact:
- Columns and pedestals showed minimal damage
- Indicates failure mechanism was superstructure uplift, not foundation instability
- Main navigation span remained intact due to higher elevation and deeper structure.

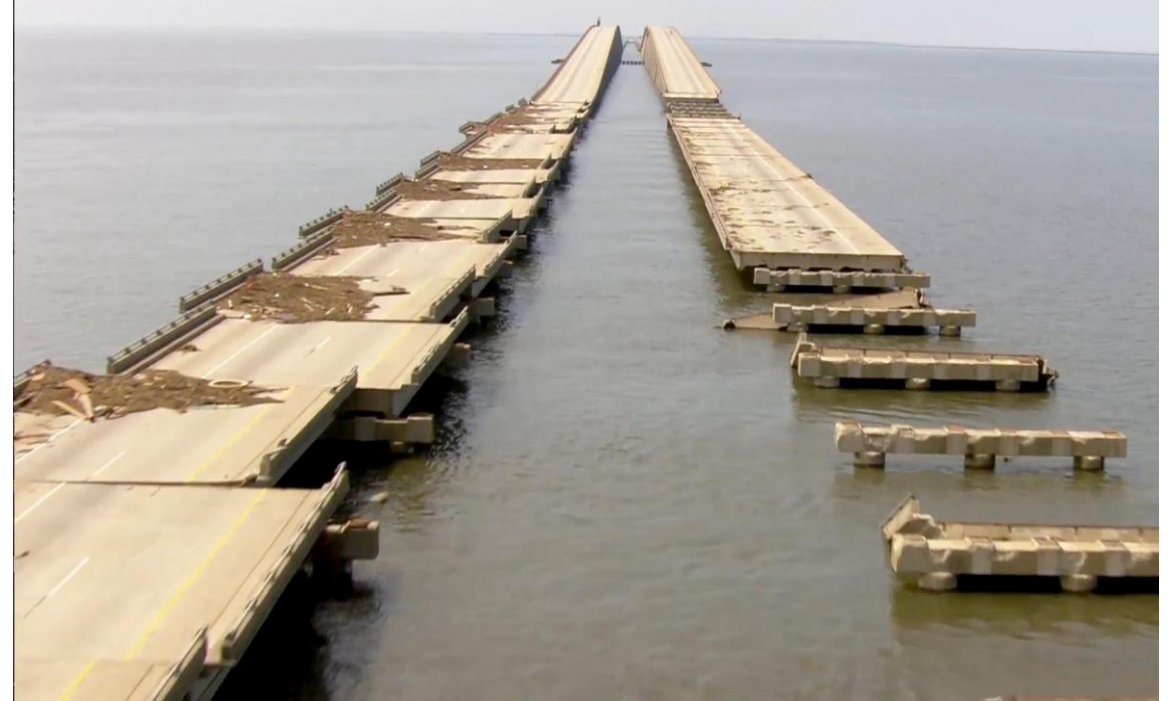
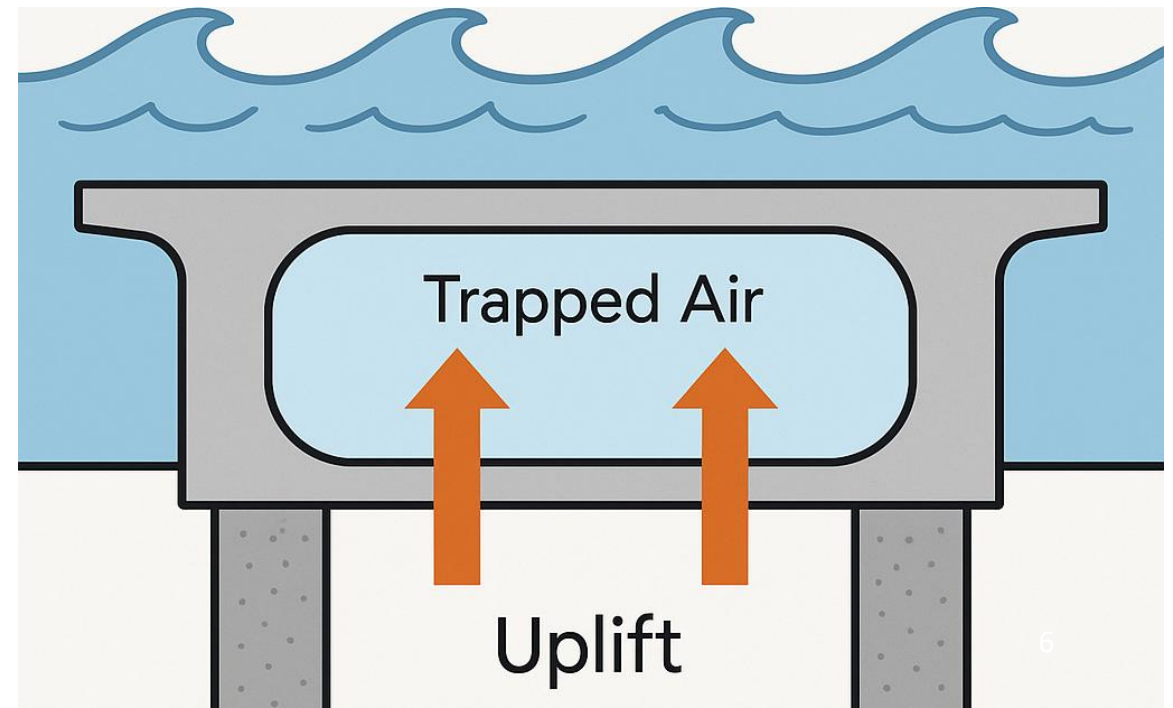
What happened

- Storm surge raised water levels beneath the bridge.
- Air became trapped inside the hollow underside of the decks.
- This trapped air reduced effective gravity load, making spans buoyant.
- Floating decks required minimal horizontal force from waves, wind, or current to shift.
- Spans moved eastward, opposite major wind direction → confirms surge-driven buoyancy caused displacement.
- Nearby bridges (U.S. 11 and railroad) experienced little to no damage

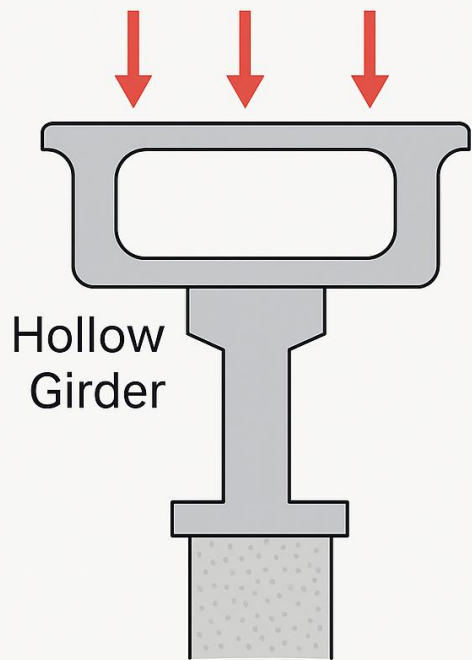
I-10 Bridge

Hollow Girder

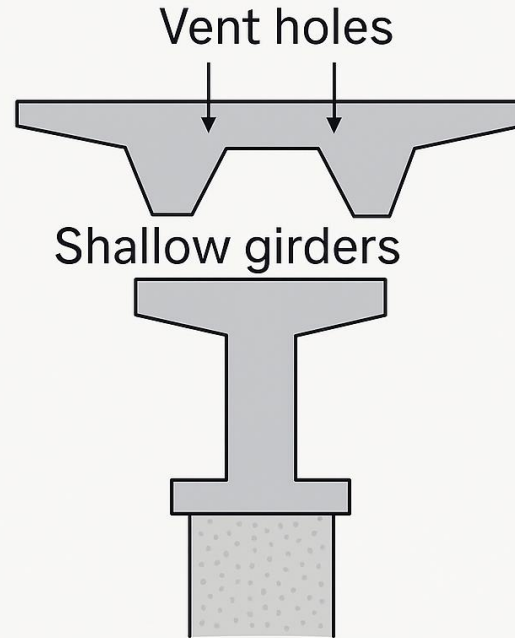
U.S. 11 Bridge

Vent holes

Shallow girders

- U.S. Highway 11 Bridge:
 - Shallow girders + vent holes prevented air entrapment
 - Lower buoyancy → spans stayed seated
- Railroad Bridge:
 - Solid slab deck → *no hollow space* for air to trap
 - Equipped with shear keys → prevented lateral movement
- Both bridges saw the same storm surge, yet remained intact → confirms that:
 - Structural geometry,
 - Air-release capability,
 - Span-to-support connectivity played a larger role in survivability than wind forces.
- Supports the conclusion that the I-10 failure was uplift-dominant, not wind-dominant.

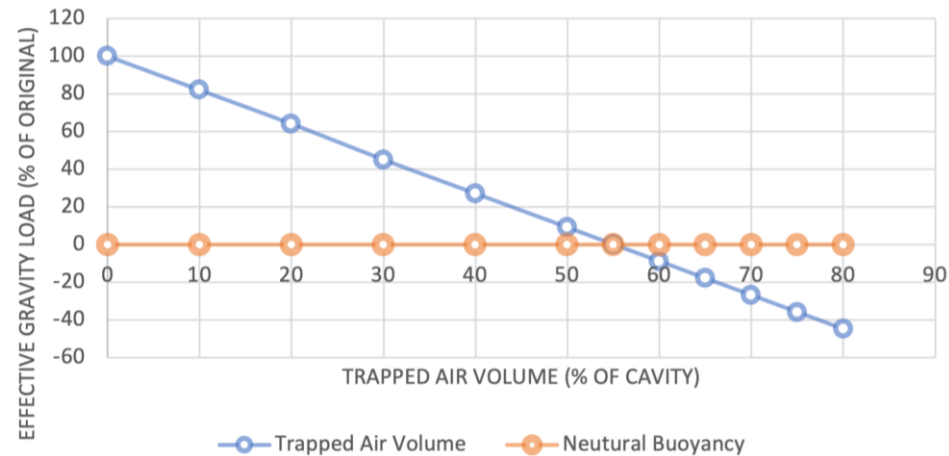
Trapped Air Volume vs Effective Gravity Load

- Hydrostatic Principle:
 - Buoyant force = weight of displaced water. Larger air cavity → smaller effective weight.
- Hydrostatic lab experiment using a rectangular box confirmed the failure mechanism.
 - Critical Threshold: 55% air volume, net gravity load = 0 → structure becomes neutrally buoyant.
 - I-10 spans had ≈70% trapped air volume, leading to flotation.
- Frictional resistance dropped, allowing spans to slide sideways.
- Structural geometry strongly influenced damage severity.
