Bridge Adaptation

Bridge Adaptation on a Global Perspective

Old I-10 Twin Span Bridge

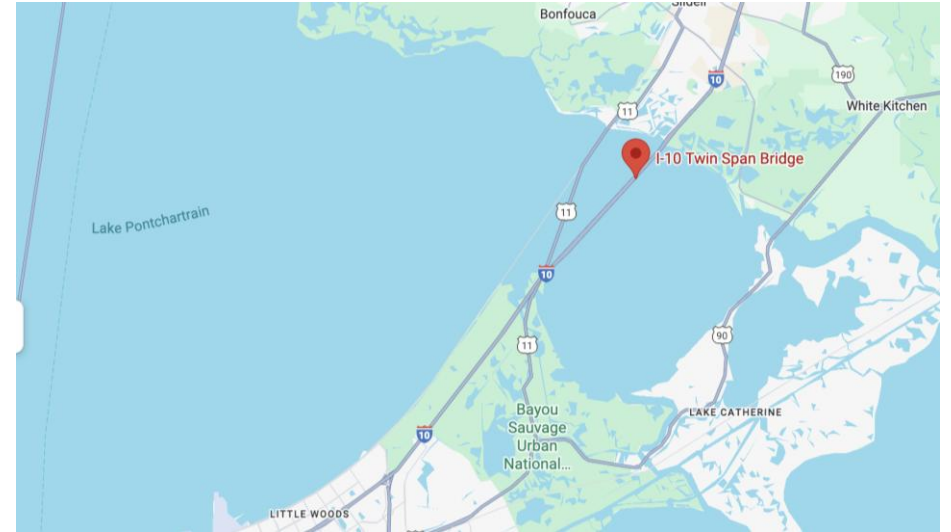
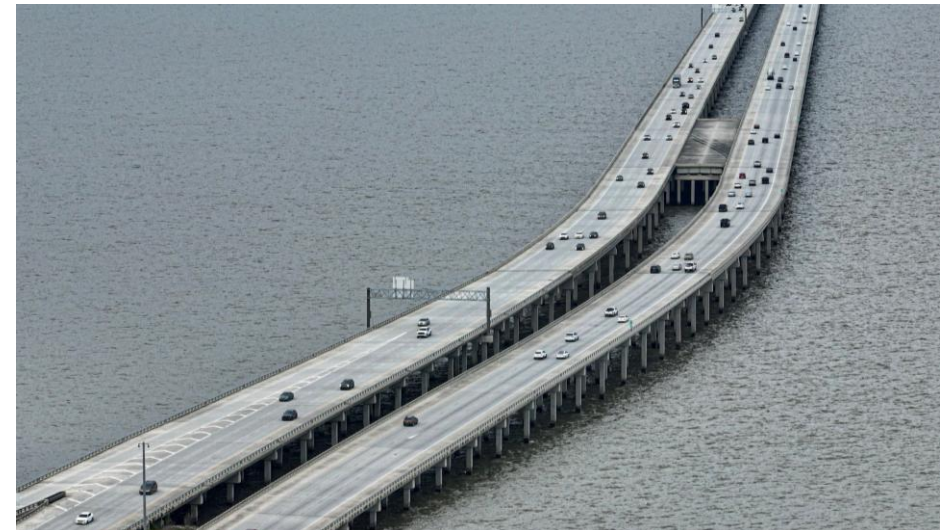
- New Orleans, one of the 3 main connections
- Construction timeline (1963 → 2005 collapse → 2011 completion)
- Built in 1963
- Length: 5.4 miles (8.6 km)
- Structure: Two parallel bridges (eastbound and westbound)
- Elevation: 8.5 ft above mean high water (approach spans)
- Span configuration: 436 simply supported precast concrete spans per approach
- weight \approx 285 tons each
- Structural detail: Box-like underside created by girders and diaphragms, open downward.

- 58 spans failed:
 - 38 eastbound spans
 - 20 westbound spans
- Lateral displacement of 1–2 girder spacings before falling off supports.
- Approach spans experienced nearly all failures — low elevation + hollow girders made them highly vulnerable.
- Substructure mostly intact:
- Columns and pedestals showed minimal damage
- Indicates failure mechanism was superstructure uplift, not foundation instability
- Main navigation span remained intact due to higher elevation and deeper structure.
